# **Gordon Hall**

## **Rehabilitation Master Plan**

Gordon Hall Local Historic District  
August 2011

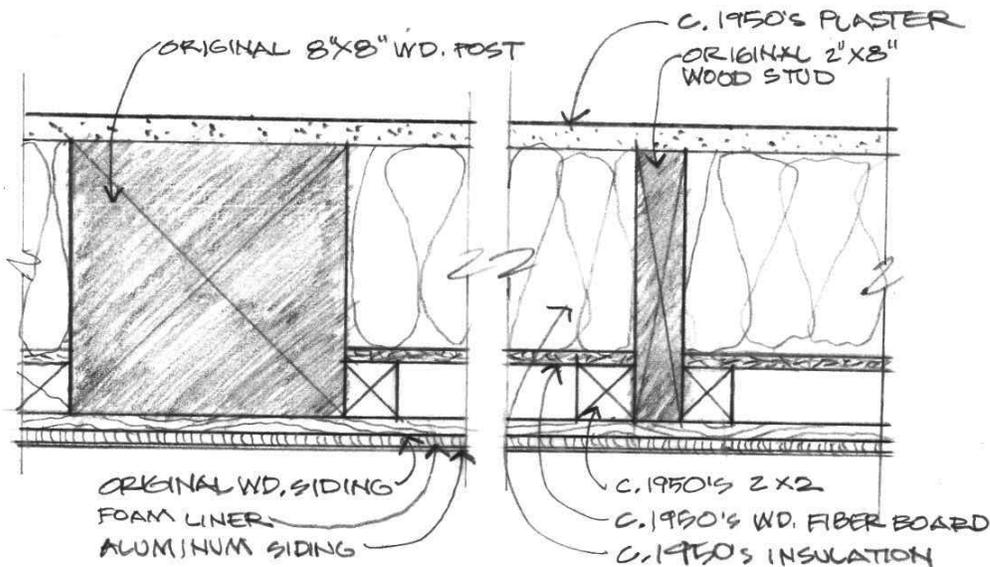
Probes into the wall from the interior revealed that the black wood fiber board was approximately 6 5/8" back from the painted surface of the plaster, while the overall thickness of the wall from the outer surface of aluminum siding to the painted surface of the plaster is 6 1/8". New studs were also observed on the interior between the fiber board and the plaster. Based on these observations It is believed that the original wall was constructed of 8" X 8" post and beam construction, with 2 X 8 studs between posts to carry the exterior siding and interior plaster. When the building was gutted, it is speculated that the wood fiber board was inserted between the original studs and posts on new 2 X 2s, likely to reduce air infiltration, since it is likely that the original clapboard siding was applied directly to the studs without any sheathing (a common building practice in the 19<sup>th</sup> century). The new studs may have been added to provide additional support for the plaster, perhaps because original stud spacing may have been greater than today's standard 16." This wall construction is depicted below.

Condition: Although it is difficult to assess the condition of the outside of the exterior walls due to the presence of aluminum siding, they appear to be generally sound and in good condition. Some potential areas of deterioration were identified at the exterior where roof water management and flashing are inadequate, however the exact conditions of these concealed areas are not known. However they are not believed to be serious, and may be limited to localized wood siding deterioration.
